Developing and Promoting the Meon Valley Trail

Final Report

June 2013

Meon Valley Trail – condition survey report

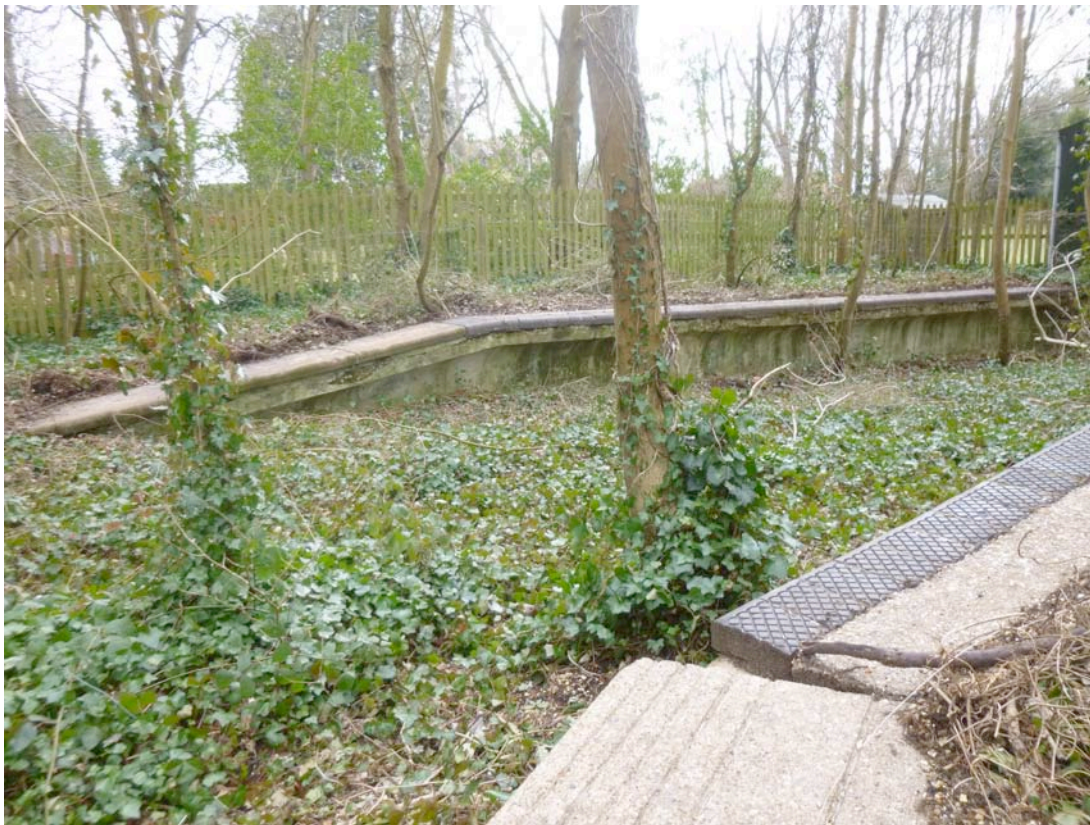
Remaining platform at Droxford Station

The railway played a crucial role in the D-Day operations, hosting a meeting of Allied leaders in a train at Droxford station. This event is commemorated with a plaque on the station building. The station is now in private ownership, but a short section of platform can still be seen and accessed by the public. This is one of the few remaining pieces of railway heritage, and it is of increased importance due to the link to the Allied leader meeting.

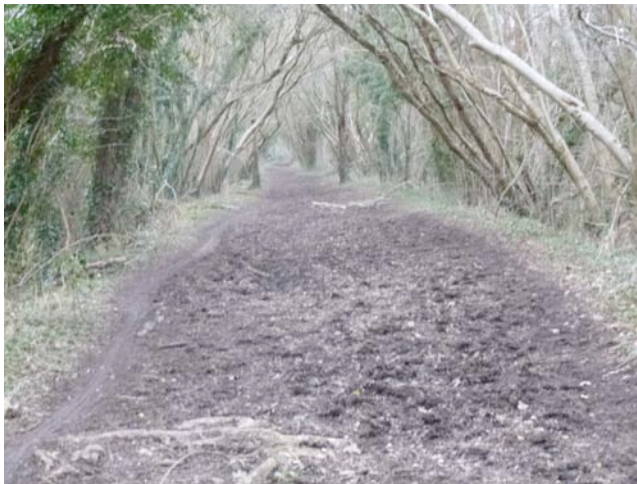
At present the MVT offers a traffic free route, but the surface is not suitable for road bikes, and in parts is unpleasant for walkers and horse riders. Improving the surface will increase the attractiveness of the MVT to families, commuters and many walkers and cyclists.

Typical view of the surface of the trail

New surfacing should be relatively fine, and rolled to create a semi-sealed surface, which is good for bikes and walkers. Loose aggregate surface is not recommended as this presents hazards to both cyclists and equestrians.

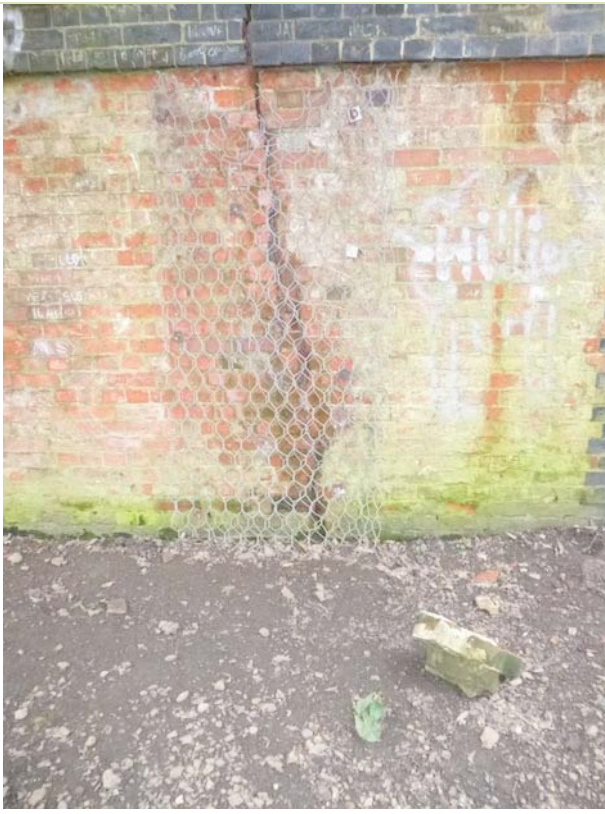
Issue	Photo
1	Section 3 – unstable bridge. Falling masonry could present a hazard. Structural survey and/or demolition is required photos 10,11,12, 13, 14

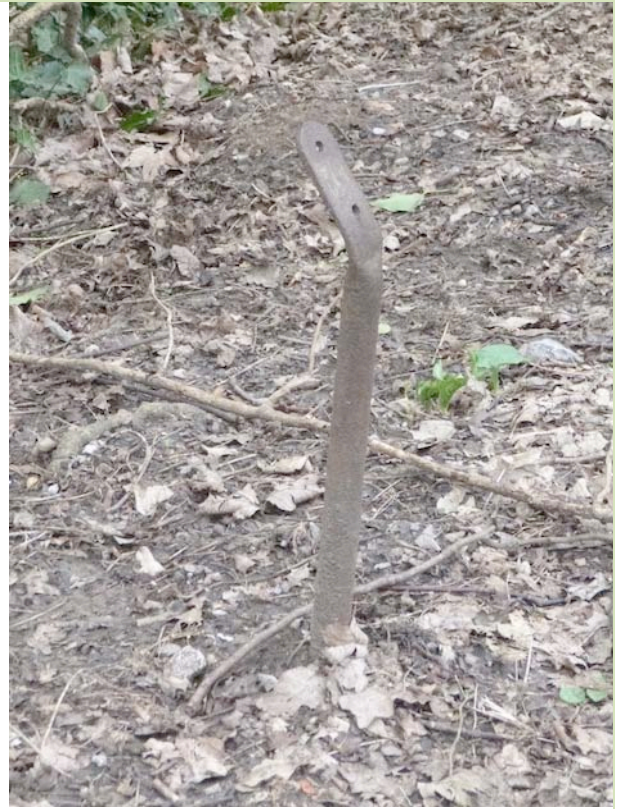
3 Section 10 – metal spike to remove near Wickham - photo 70

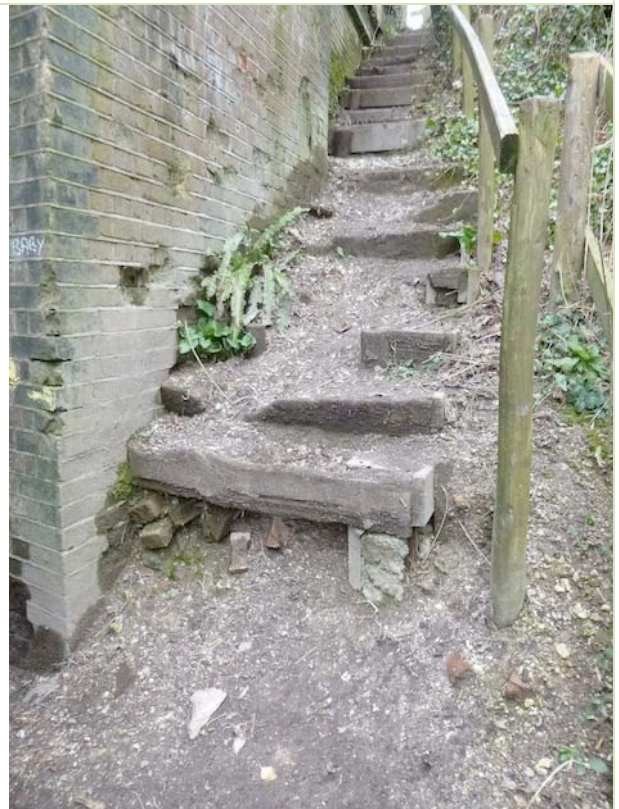
4 Section 23 – access steps in poor condition photo - 191

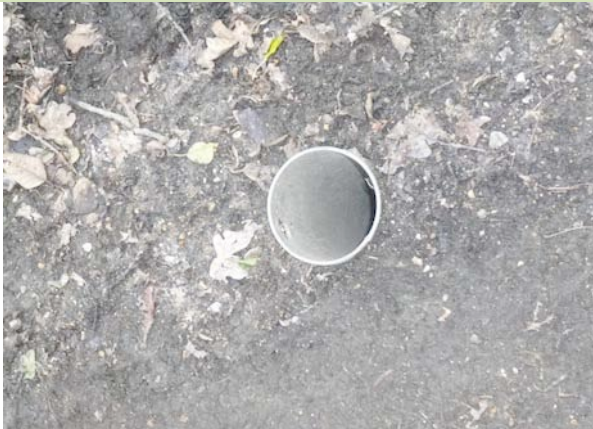
5	Section 35 - Missing bollard – creating a hole in the trail surface. Photo 287,288, 289,290

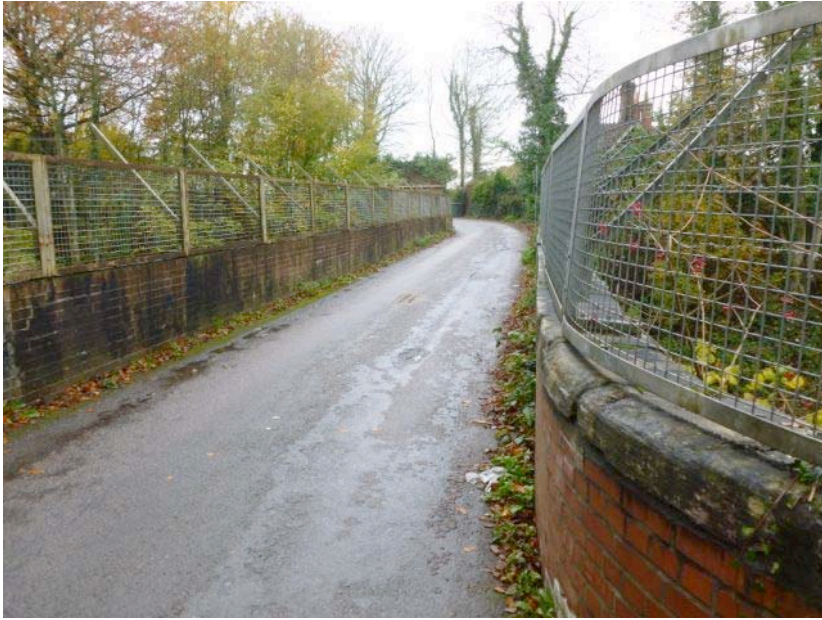
Photo 4

While the development proposals above could lead to an additional crossing of the live Fareham-Eastleigh railway line, in the short term the two existing bridges over it (the northern bridge being single carriageway (marked as A on Figure 1. Also see photos 4 and 5), the other pedestrians width only (marked as B on Figure 1. Also see photo 6), plus the restricted M27 underpass (marked as C on Figure 2. Also see photo 7), present fixed strategic constraints when considering links to the south of Knowle.

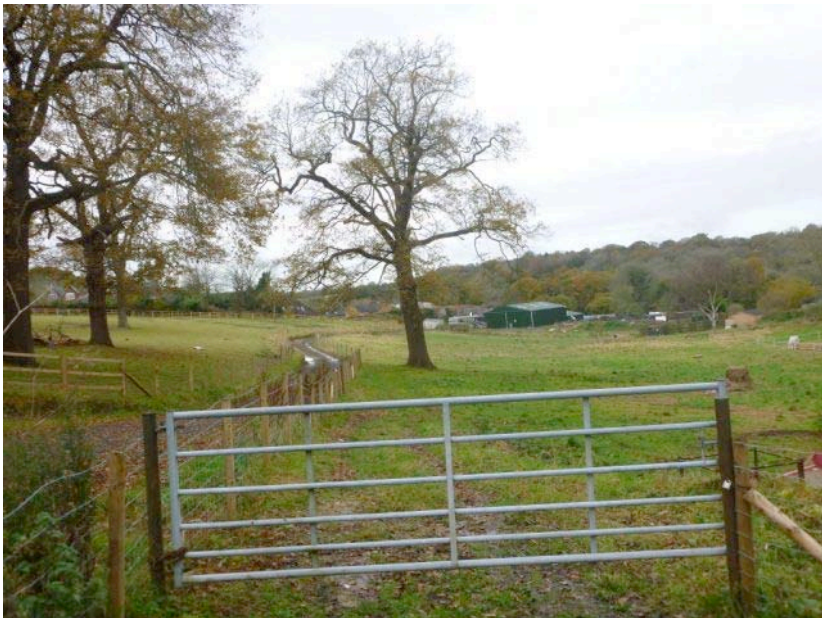
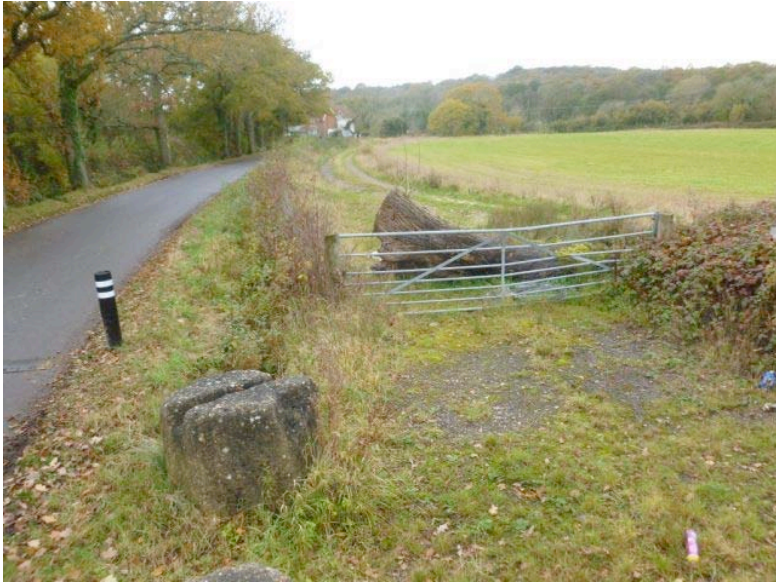
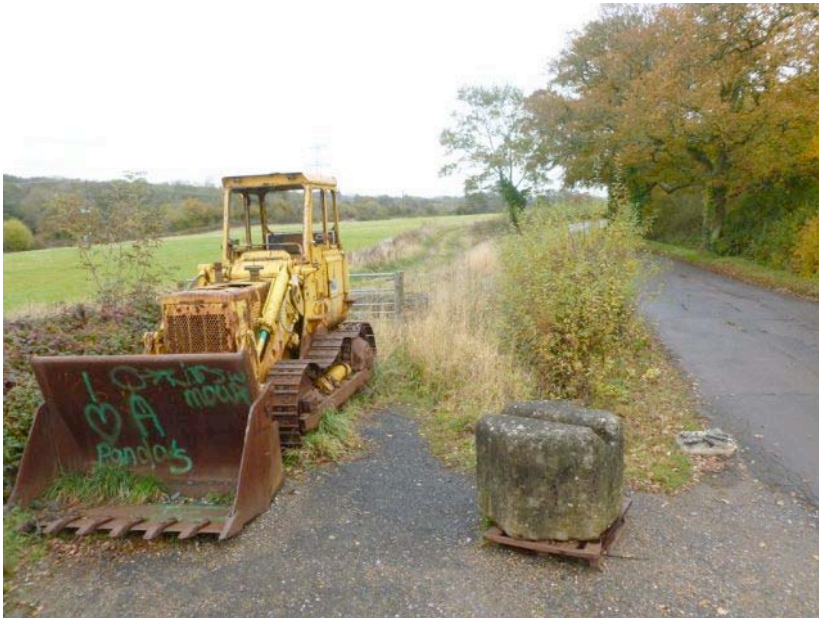
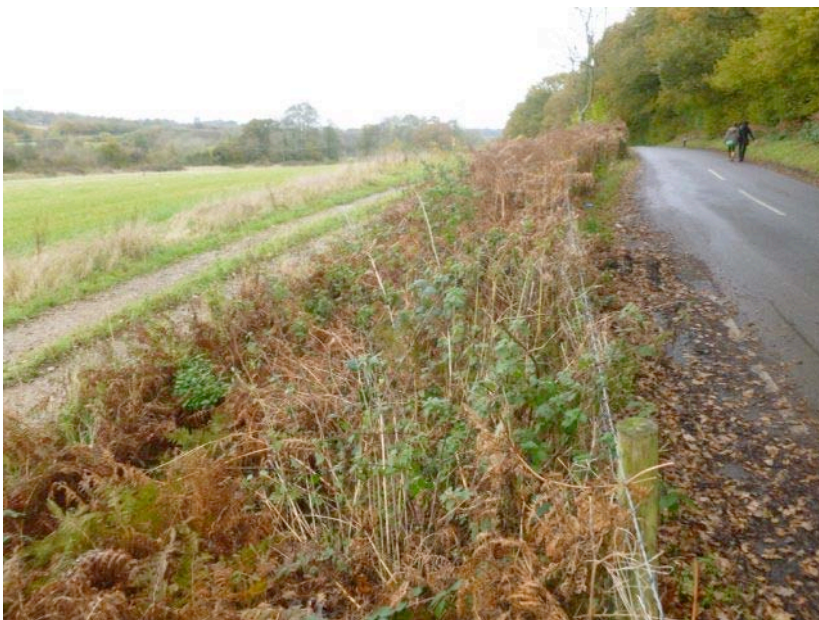
To the north of Knowle, past HCC contact with a significant owner of land between the trail and Mayles Lane, and the well-maintained fences and locked gates (see photos 8-11) that exclude the public from this land (where tracks linking to the trail do physically exist for private use), suggest that agreement to provide additional access, even permissive, is unlikely. For this reason, in the short-term, opportunities to connect the trail's track bed to the west of Wickham are held to be unrealistic due to landowner objection and the cost to achieve through creation orders.

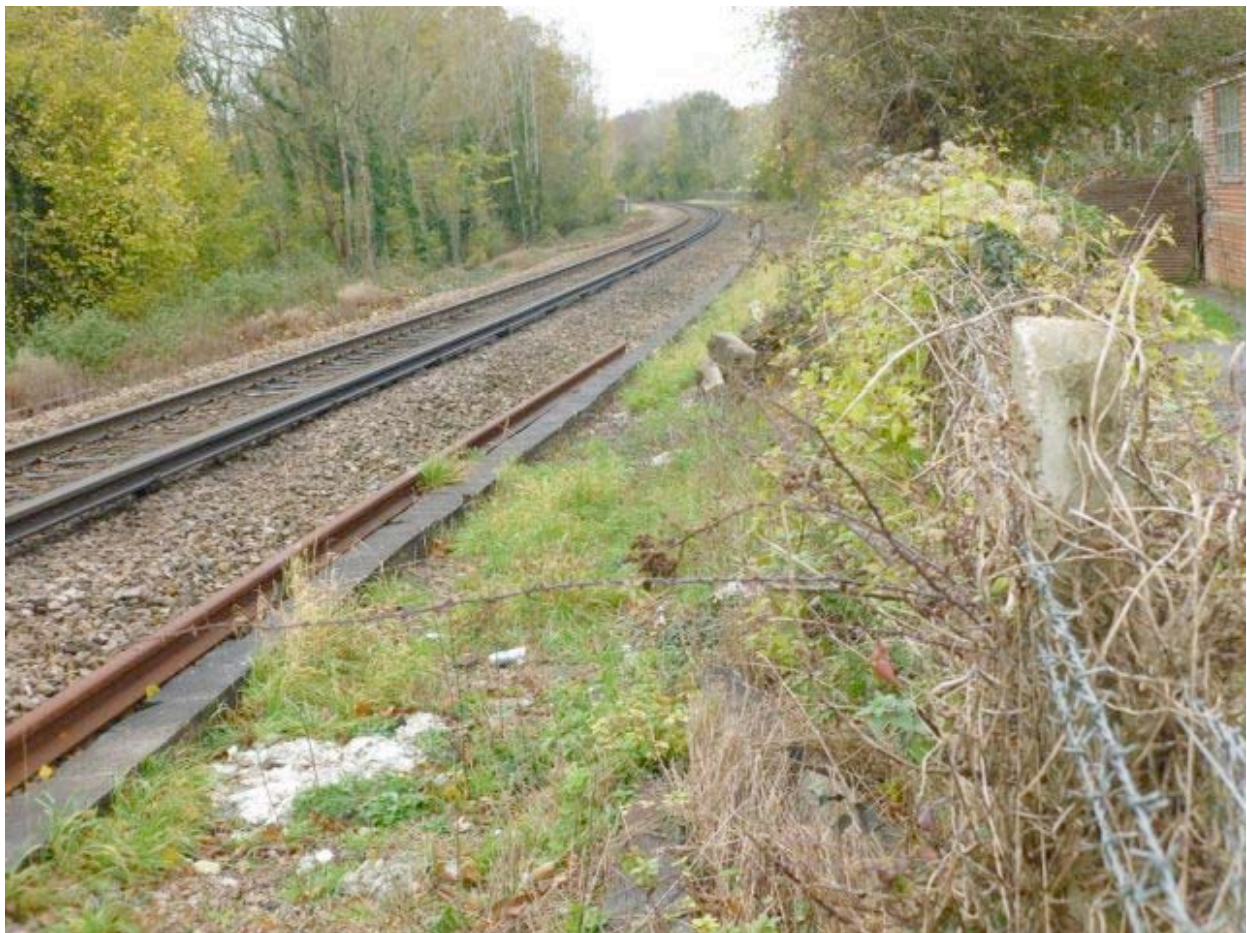
**Photo
12**

If the proposed reopening of the railway station (marked as D on Figure 1. Also see photo 12) at Knowle goes ahead Mayles Lane, in whole or in part, is very likely to require greater public status as it is a key link, or least needs to be crossed, to access the station site.

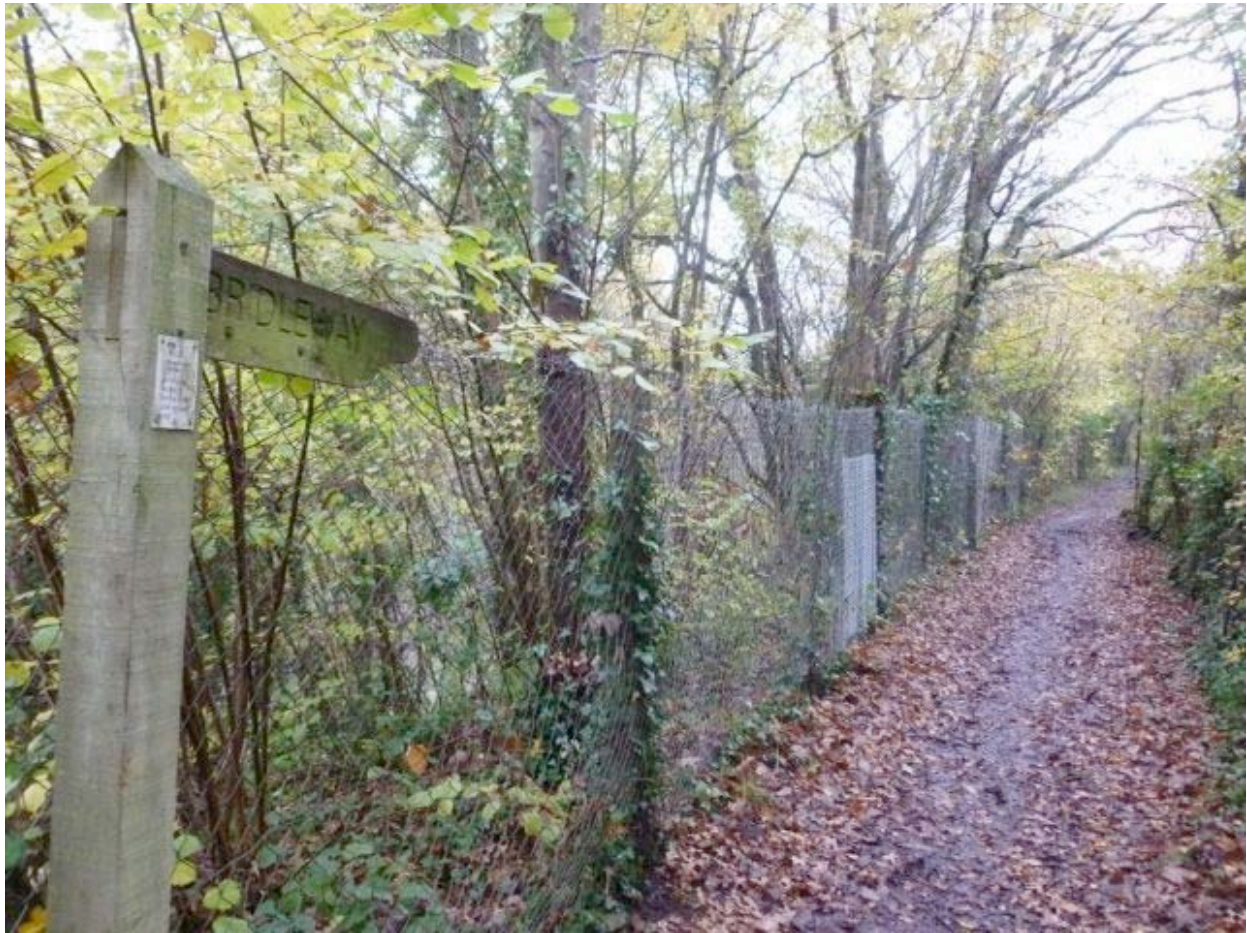
**Photo
13**

A key improvement to action in the short term would be re-grading and widening of the narrow link path between the disused track bed and Mayles Lane adjacent to the railway footbridge (marked as E on Figure 1. Also see photo 13) subject to landowner consultation.

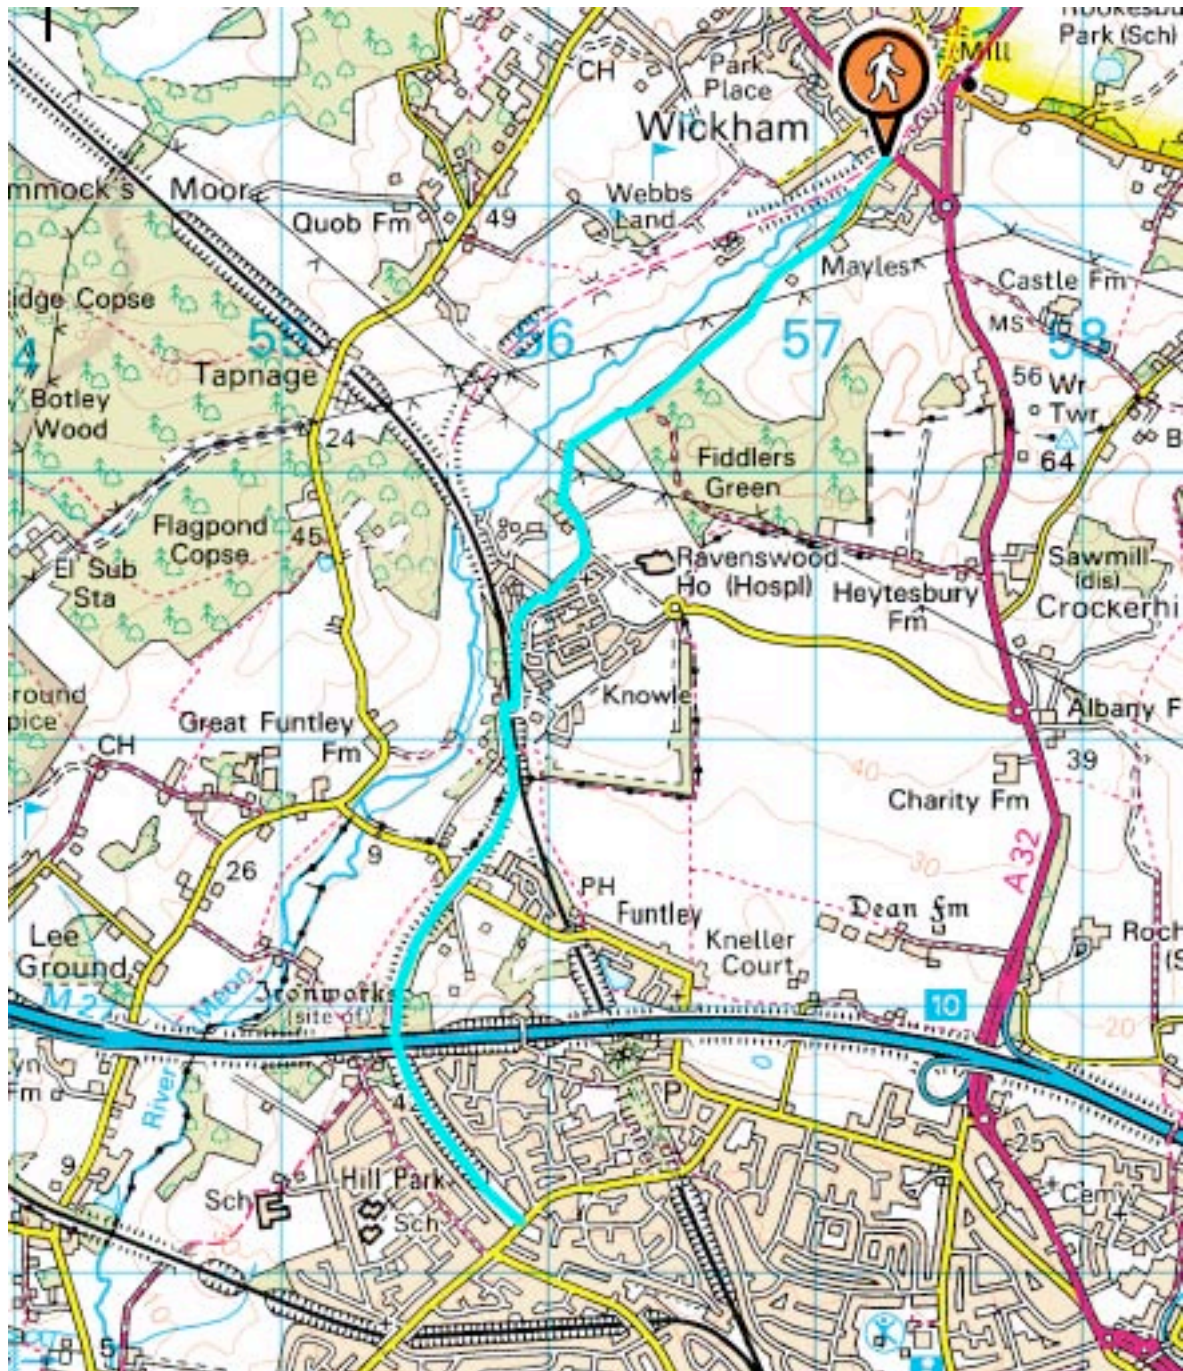
Map 1

This is a utilitarian route that could be promoted now as it is currently used. Best for commuting utilitarian cyclists but open to all, though for horse riders motorway underpass will be problem for some. Some improvements to surfacing on section from motorway north to Mayles Lane by railway bridge would be helpful.

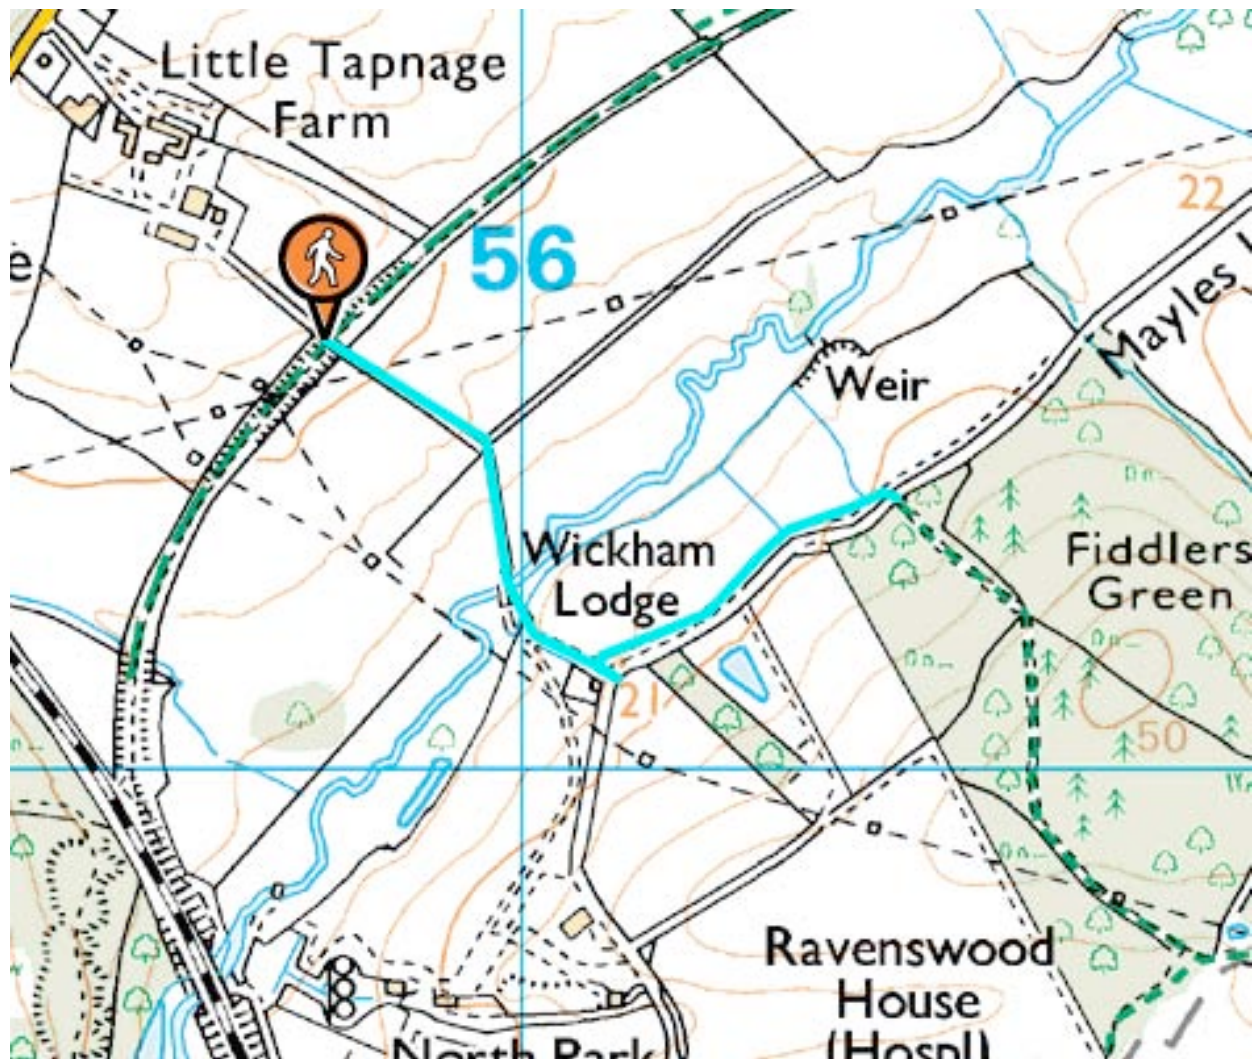
Map 2

This is the most practical way to link the trail onto Mayles Lane (though it has only been surveyed from road and air photographs), as it uses existing bridges and stoned tracks and would seem less of a challenge for a creation order or planning related provision.

The route runs along a track on the field side of a wall to link with path through Fiddlers Green Wood, plus a connection by Wickham Lodge for people wanting to go south on Mayles Lane. There could also be a potential link going north-west to road somewhere around Little Tapnage Farm, but this has not been surveyed.
